FIRE IN THE ENGINE ROOM!

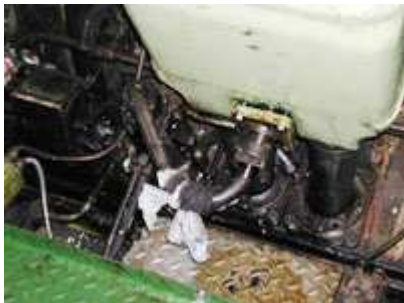
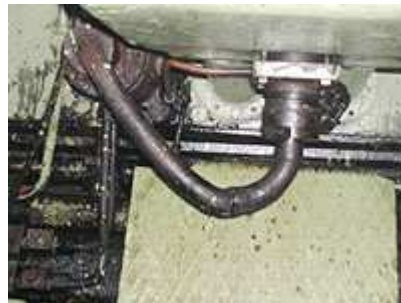
Because of the high risk and severe consequences from high-pressure oil line leaks the fuel oil pump discharge lines are double skinned so that any fuel leaks are contained and the leakages safely drained to a tank. The integrity of the outer skin is essential to prevent any leaking oil from spraying over a hot surface and the consequent fire.

DO ensure that the outer protective skin of fuel oil pump discharge lines is frequently checked and immediately renewed if any damage or deterioration is found. The photographs above show examples of double-skinned high-pressure lines that need to be renewed.

DO regularly check the fuel oil drain tank and ensure the alarm is functioning to ensure that any leakage from the inner pipe is detected.

DO confirm that the remote stops and quick-closing valve mechanisms work by regular testing – and that ship's staff know where they are and how to use them.
